# Manhole Inspection Summary

Manhole # S31G\_\_025MH

**Inspection** ☐ Is Incomplete Rating: **5) Immediate Attention Required**

**Location** Address: **1 n eutaw st**

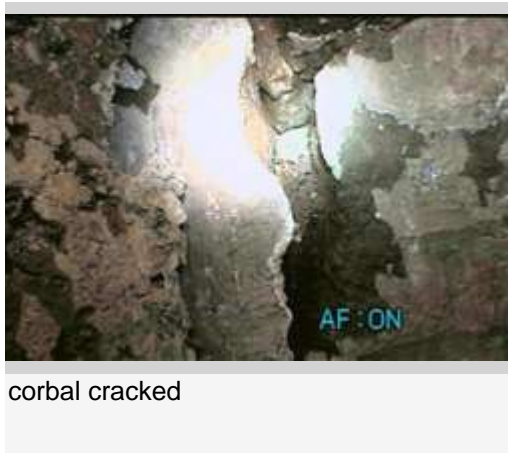
Defect 5

Condition: ☐ Sound ☒ **Cracked** ☐ Root Intrusion ☐ Loose Brick ☐ Deteriorated

corbel cracked

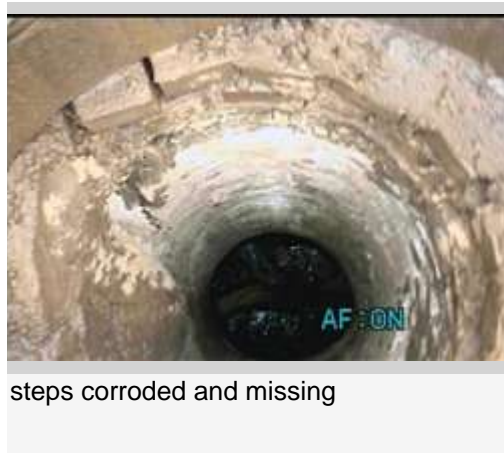
Defect 4

Count: **8** Missing: **8** ☒ **Corroded**

steps corroded and missing

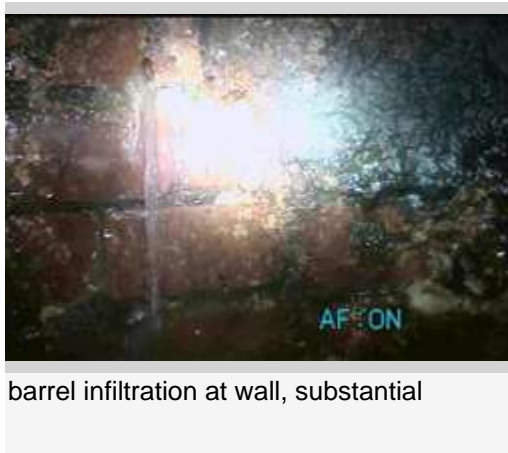
Defect 3

Infiltration: ☐ None ☐ Joint ☐ Cracks ☐ Mortar ☐ Roots ☒ **Wall**

barrel infiltration at wall, substantial

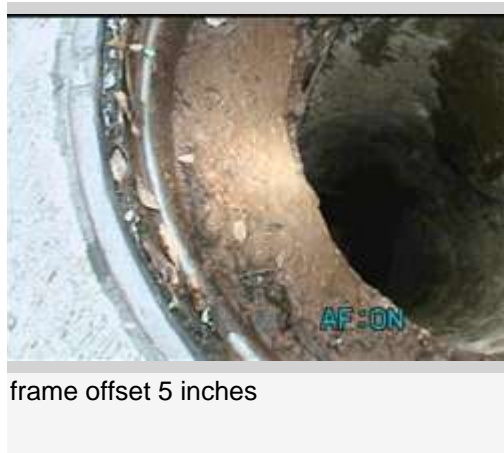
Defect 2

Offset: **6** (in.)

frame offset 5 inches

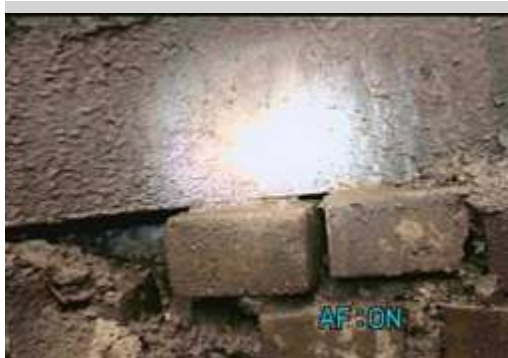
### Defect 1

Condition: ☐ Sound ☐ Cracked ☐ Root Intrusion ☐ Loose Brick ☒ **Deteriorated**

chimney deteriorated at frame joint

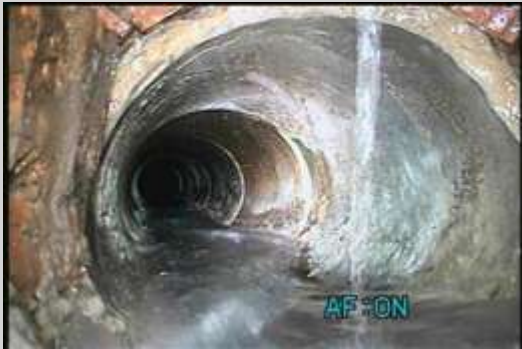
12 O'Clock Outflow

12 in. Circular Gravity Sewer  
Pipe Out @ 12 O'Clock

Pipe Material: **Clay** ☐ Pipe Lined

Invert Depth: **18.92** (ft.) Flow Characteristics: **Fast**

Infiltration: **None** Pipe Seal Cond: **Unknown**

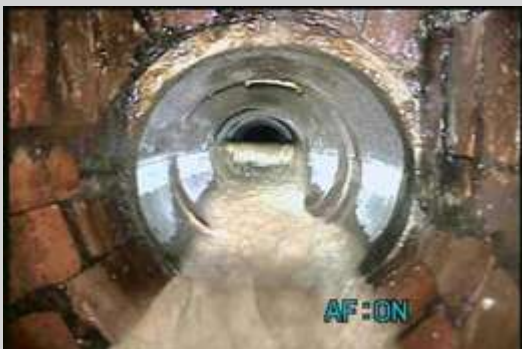
6 O'Clock Inflow

10 in. Circular Gravity Sewer  
Pipe In @ 6 O'Clock

Pipe Material: **Clay** ☐ Pipe Lined

Invert Depth: **18.50** (ft.) Flow Characteristics: **Fast**

Infiltration: **None** Pipe Seal Cond: **Unknown**

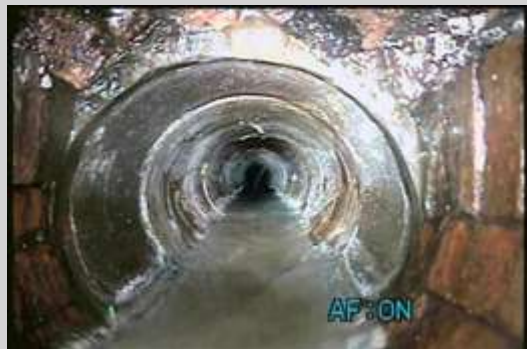
9 O'Clock Inflow

12 in. Circular Gravity Sewer  
Pipe In @ 9 O'Clock

Pipe Material: **Clay** ☐ Pipe Lined

Invert Depth: **18.58** (ft.) Flow Characteristics: **Fast**

Infiltration: **None** Pipe Seal Cond: **Unknown**
